MBTA Green Line Climate Change Vulnerability Assessment

Project Summary Presentation

June 14, 2022

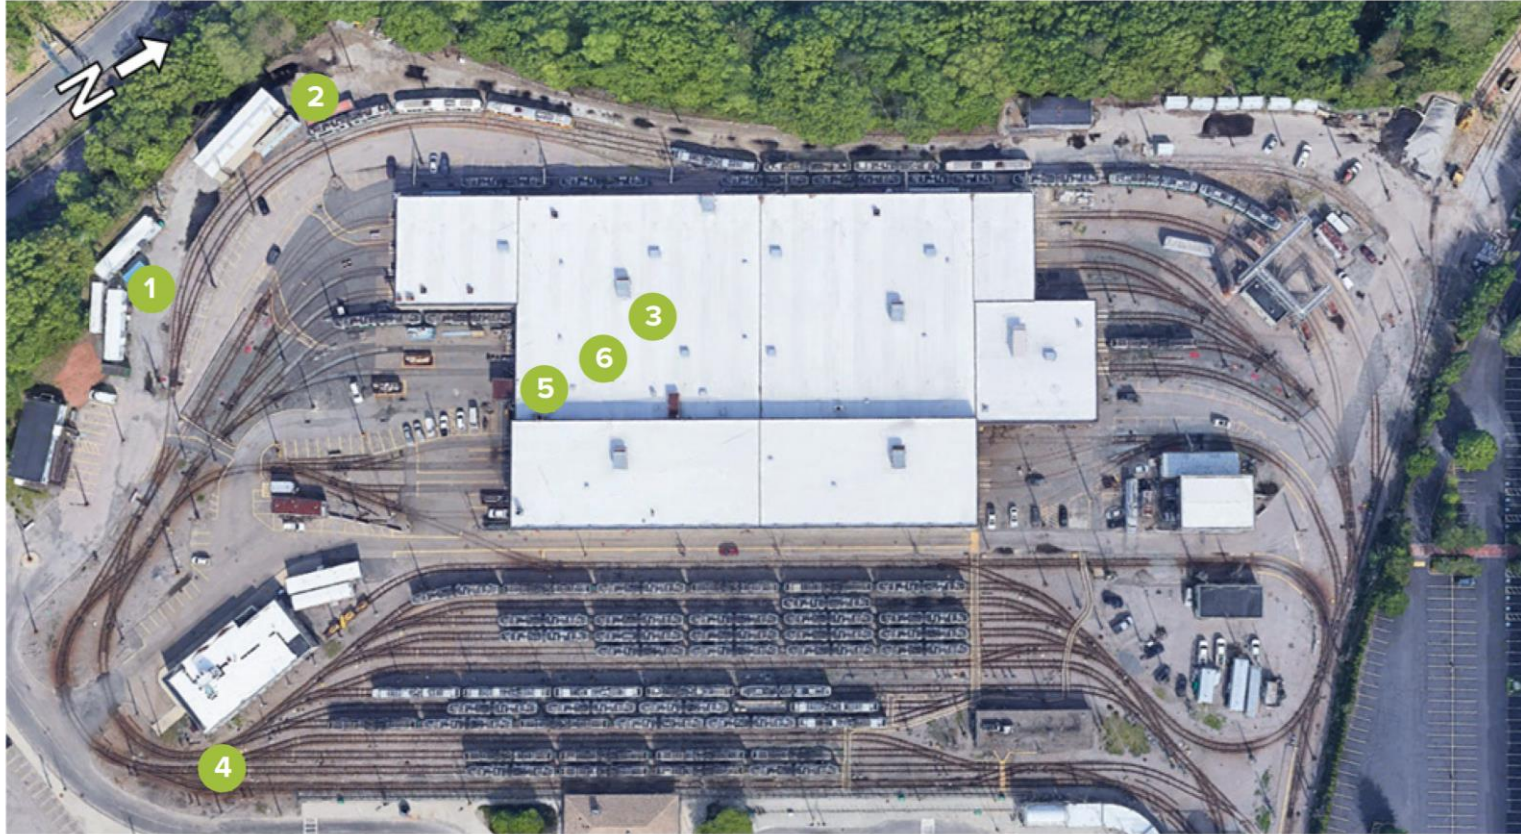
Key Vulnerabilities at Riverside Yard

1. **Auxiliary buildings** are modular and may be susceptible to damage in severe storm events but also allow for easy replacement.

2. The west end of the yard is surrounded by **tall trees** that hang over catenary cables in some areas. Potential for impacts from extreme wind and storm events.

3. **Compressors** are prone to overheating due to constant use, leading to staff discomfort or equipment shutdown which could be exacerbated by extreme heat events.

4. **Switch heaters** are sufficient to manage gradual snowfall but may not be sufficient during severe winter storms.

5. An **emergency generator** is located in the basement and may be susceptible to flooding during extreme precipitation events.

6. **Truing machine** is located below grade in a pit and may be susceptible to flooding during extreme precipitation events which could damage machinery and impact operation.

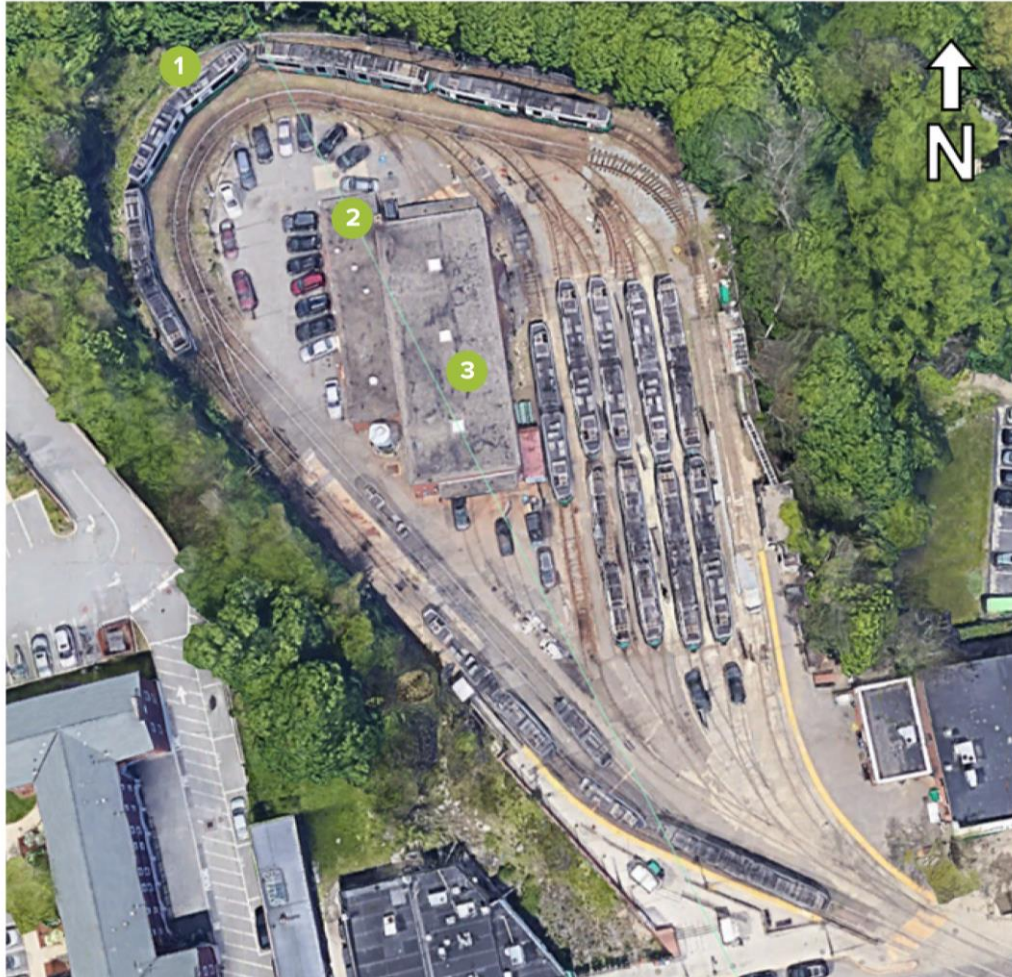
Key Vulnerabilities at Lake Street Carhouse

1. **Trees** overhang catenary cables in some areas. Potential for downed branches during extreme wind or storm events which may damage catenary.

2. **Carhouse** overheats during heat waves, including **compressor room** due to constant use, which can inhibit maintenance work or lead to equipment shutdown. This may be further exacerbated by increases in extreme heat events.

3. **Trough drains** at facility entrances are undersized and have flooded in the past, introducing water into **maintenance pits**. This may be exacerbated by extreme precipitation due to climate change.

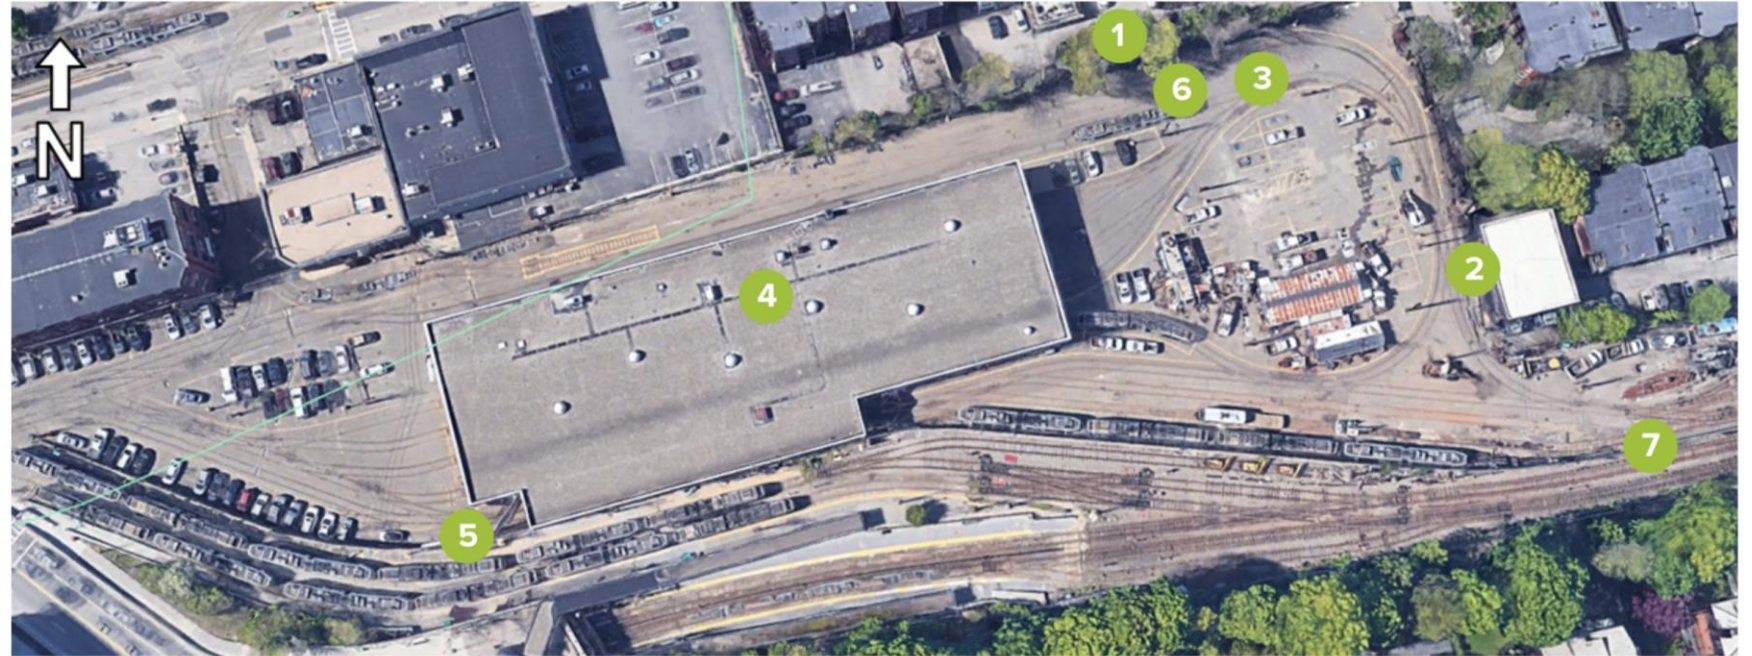
Key Vulnerabilities at Reservoir Carhouse

1 & 2. The upper yard is flanked by **trees** towards the main line connection, with trees hanging over walls and catenary. This may cause damage in extreme wind events.

3. Some **switches** do not have **switch heaters**, and manual snow clearance is required. This may result in additional manual labor in extreme winter weather events.

4. Facility **roof** is nearing end of life and will be replaced. When replaced, ensure roof is re-designed for future climatic conditions.

5. Clogged **weep holes** in retaining walls can lead to increased groundwater and higher hydrostatic pressure on the wall. This may be exacerbated by extreme precipitation.

6. Clogged **trench drains** resulting in a reduced drainage capacity and increased flood vulnerability under current precipitation conditions. This may be exacerbated by extreme precipitation.

7. The **ballast** throughout the yard was flooded with sand from sweeping out train cars leading to reduced permeability. This may result in flooding with increased precipitation.
