Z94PS08 - GEC Task Order No. 814

Shock Investigation of Fiber Reinforced Polymer
at the Mattapan DCR Pedestrian Bridge

January 2022

MBTA
Office of Chief Engineer
10 Park Plaza
Boston, MA 02116

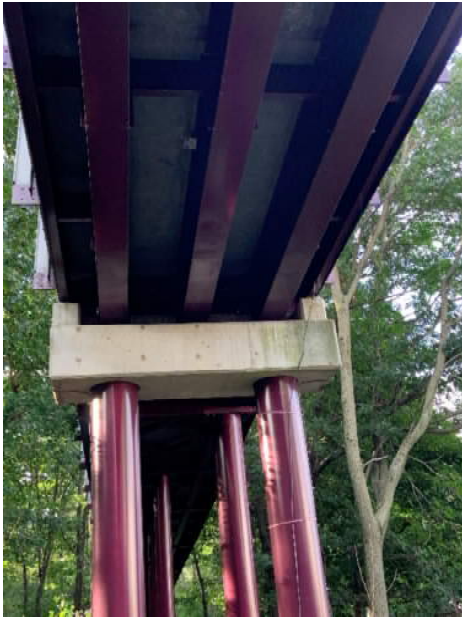
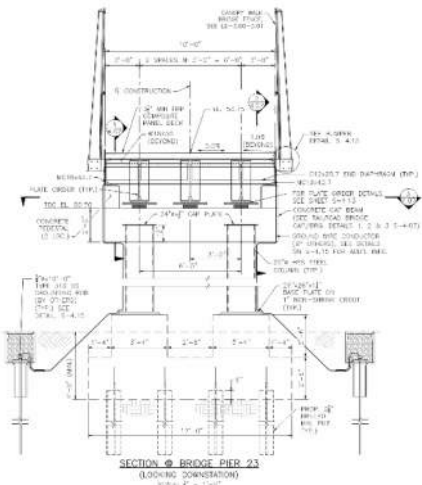
Bridge Pier 23 Looking towards Milton

Pedestrian bridge looking towards Milton, south end (Pier 23). A bare copper 2/0AWG ground conductor loop is routed from a ground connection at the bottom of the right column, up to the bridge on the right column, across the bridge making cadweld connections to the steel, down the left column and appears to enter a ground well adjacent to the foundation. Additionally, there appears to be an insulated ground conductor, fastened with a beam clamp, running down the right column to the left column anchor bolt and terminating on the right column anchor bolt. A similar installation is seen on the columns when looking towards the Mattapan side, northern side (Bridge Pier 24).

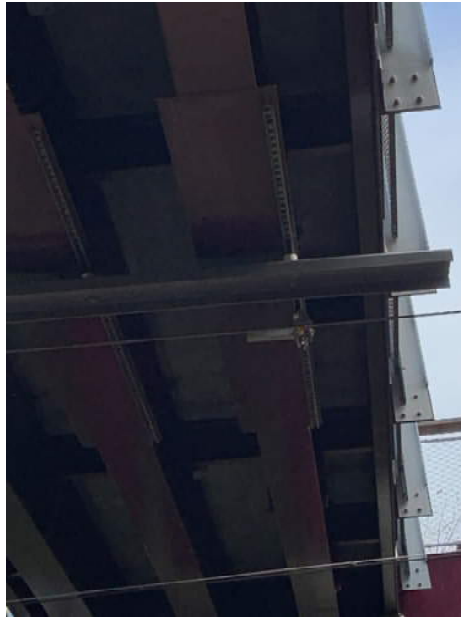
Underside of Bridge and the Catenary "shield"

The bottom of the bridge appears to conform with the design documents illustrating the fiberglass "shield" between the bridge structure and the overhead catenary wire.

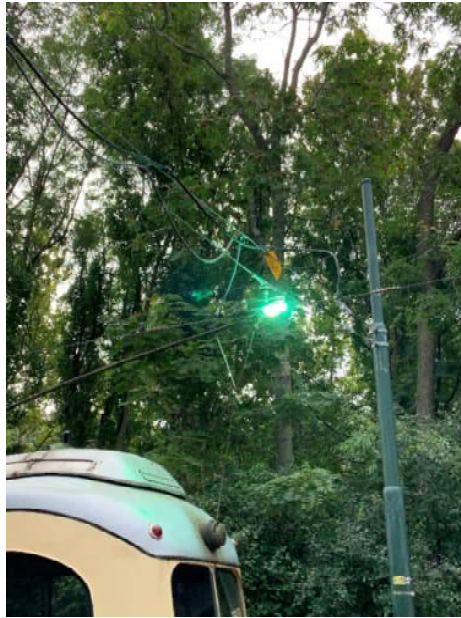
Trolley #3268 passing the Catenary cutout switch

It was observed that trolley #3268, primarily, created a spark when passing the cutout on the outbound track. This appeared each time during this site visit but did not repeat for the inbound track nor on later site visits.

3. Repair the pantograph wheel on trolley #3268 as it appears to be the only trolley that produces the spark at the Northbound cutout switch just past the bridge. The spark seen can cause a psychological effect of people walking across the bridge, especially if a static shock is also experienced leading them to believe the Overhead catenary contributed to the unpleasant shock.

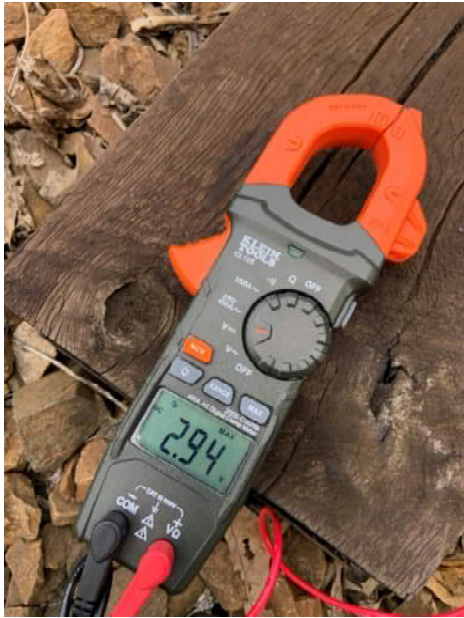
Stray Voltage Measurement
(Outbound of Station Track to Fence)

During the time on the track Right of Way (ROW), there was an attempt to measure any potential differences that may be the result of Stray Current/Voltage conditions. The MAX feature of an “uncalibrated” Klein Tools CL120 DMM yielded 2.94V DC (Max) for a period of about 5 minutes. This value fluctuated between 0.449 to 2.94VDC during this time frame. This measurement was a spot check and was only tested at this location between the track and the fence post.

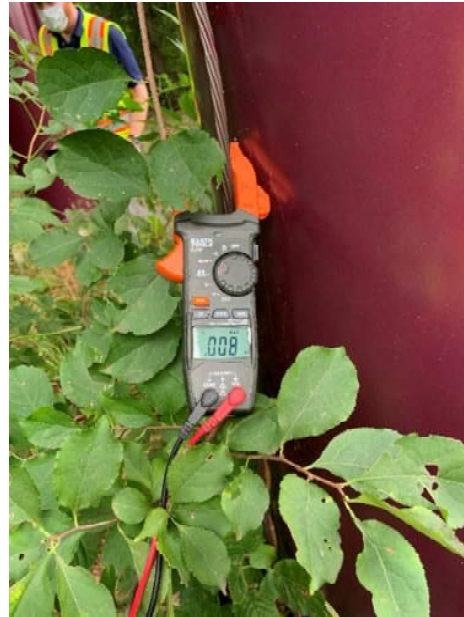
Bare Conductor
(Bridge Pier 23) Measurement

The ground conductors were tested for current flow using the “clamp on” feature of the meter. A measured value of 0.014A on the 1/OAWG bare copper down conductor, and 0.009A on the supplemental; insulated down conductor. These readings were performed on the Bridge Pier 23 structure where the 1/O bare copper down conductors drop on each leg and the apparent supplemental insulated down conductor is “zip tied” to one of the legs closest to the station. The supplemental conductor connects at the anchor bolts.

These test results proved inconclusive due to lack of equipment accuracy of the equipment used. CPI installed a 30-day data logger to the points of Bridge Pier 23 to identify potential stray currents over time. This process is described in Section 3.3.

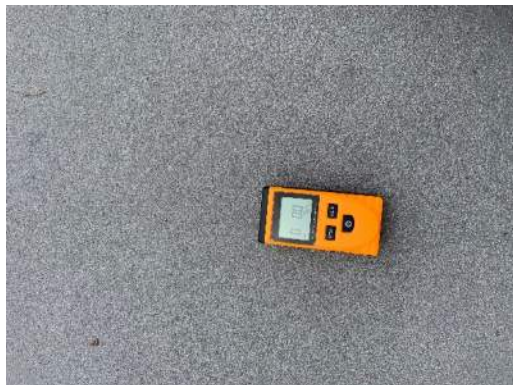
Surface Resistivity Meter

Resistivity, voltage, and static measurements were taken of the FRP decking material at the pedestrian bridge level. Resistivity measurements did not result in any findings due to the rough, gritty texture of the FRP walkway. There were no measured voltage readings from railing mesh to railing mesh and there was not a “good” common reference to measure to as well. Measured static charge was low.

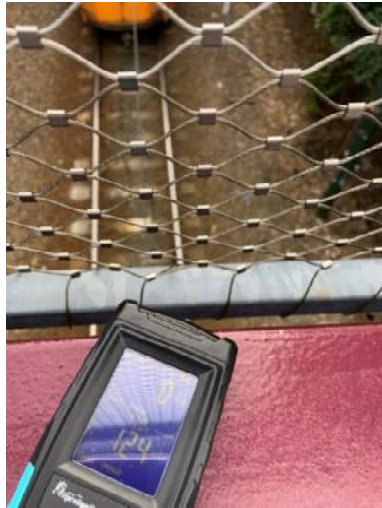
EMF reading with passing trolley

Electro Magnetic Fields (EMF) measurements resulting from the 600VDC overhead catenary system were taken from the bridge span. The values measured were comparatively low. Readings of 0 V/m (Volts per meter) and 0.39 μ T (micro-Tesla) or 3.9x10⁻³G (Gauss) to 0 V/m and 1.24 μ T or 0.01G were observed - the lower reading of .39 μ T was measured with no trolley traffic, and the higher reading of 1.24 μ T was taken when a trolley passed under the bridge. By comparison, a microwave oven will produce approximately 200 μ T.

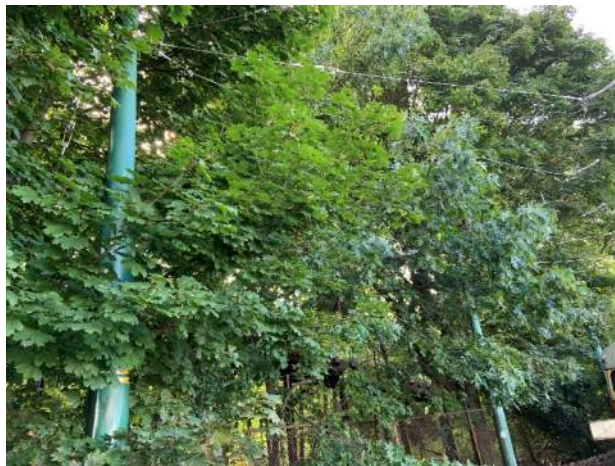
It was observed that the Mattapan station maintenance turn-around appears to have an overgrowth of tree limbs encroaching upon the overhead catenary lines and support cables. Some locations appear to be brushed by the trolley when passing. It is strongly recommended branches be trimmed back to the fence line to avoid any issues.

(Maintenance Loop – Tree Trimming needed)

2. Cut back the tree overgrowth at the maintenance yard turnaround to keep branches off the overhead catenary and support systems. Branches should be cut back to the fence or beyond to avoid any possibility of contact with the catenary. Branches should also be trimmed back from making contact with the pedestrian bridge as well. There could be contact between the overhead catenary and the bridge via tree branches and if condition is very wet, a path could be established between the catenary and the bridge ramp.

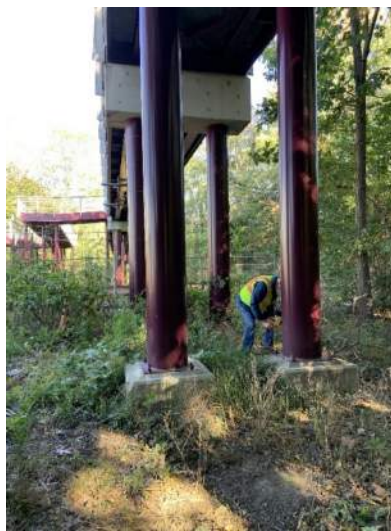
Bridge Pier 24

The conductivity test identified that the Mattapan/Boston side ramp was not electrically connected to the bridge and will require a 1/O connection to the ground conductors on the Piers 24.

1. DCR should connect the Mattapan side, or north end ramp to the bridge with a 1/OAWG ground conductor. This will provide electrical continuity between the two (2) structures and result in zero (0) volts difference between them. The Milton side, or south end ramps are already electrically continuous with the bridge as verified with field measurements by Corrosion Probe Inc. (CPI). See Section 8, DCR Sketch for proposed ground cable connection.

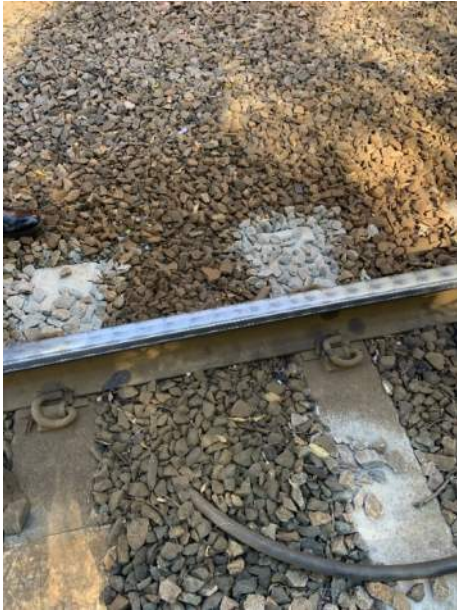
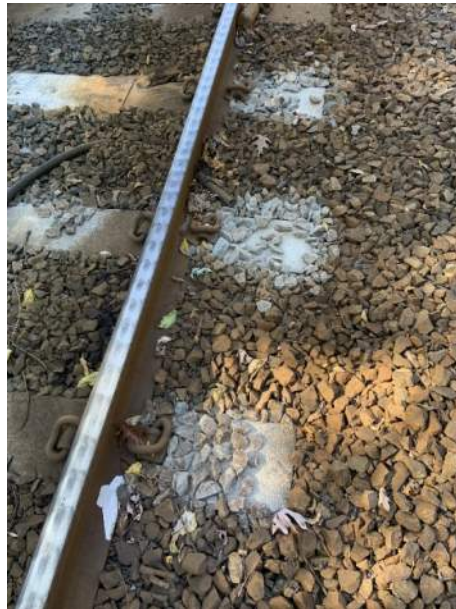
Discoloration Outbound of Station

A bleaching effect of the ballast and ties was observed on the outbound track past the bridge, whereas the surrounding ballasts and ties have a rust discoloration. Outbound of Station

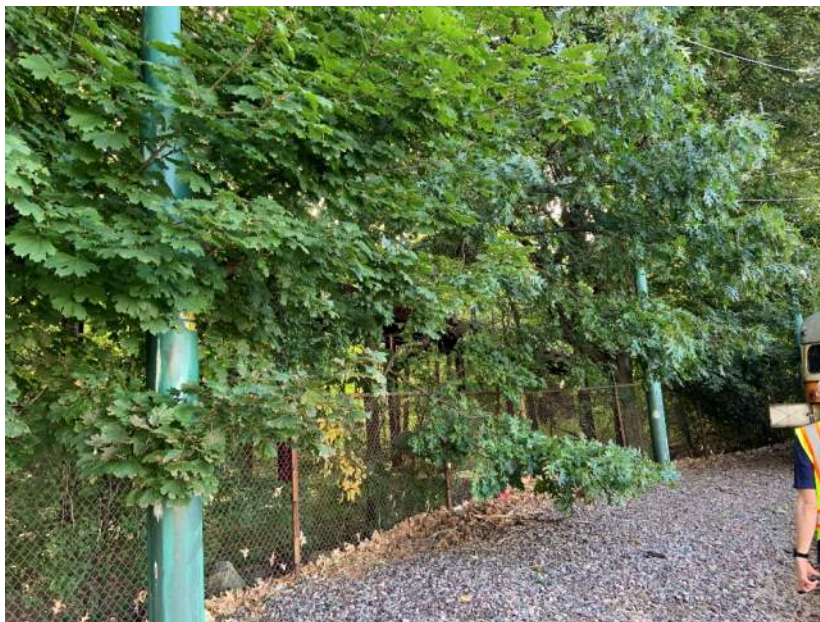
The station overgrowth, although not measurable, under certain conditions could conduct electricity from the overhead catenary to the bridge structure area if the branches are in contact

with the catenary lines and the bridge. This is a potentially dangerous situation and therefore it is highly recommended that these branches be cut back to the fence line to prevent any such incidents from occurring.

OVERGROWTH AROUND MAINTENANCE YARD TURNAROUND

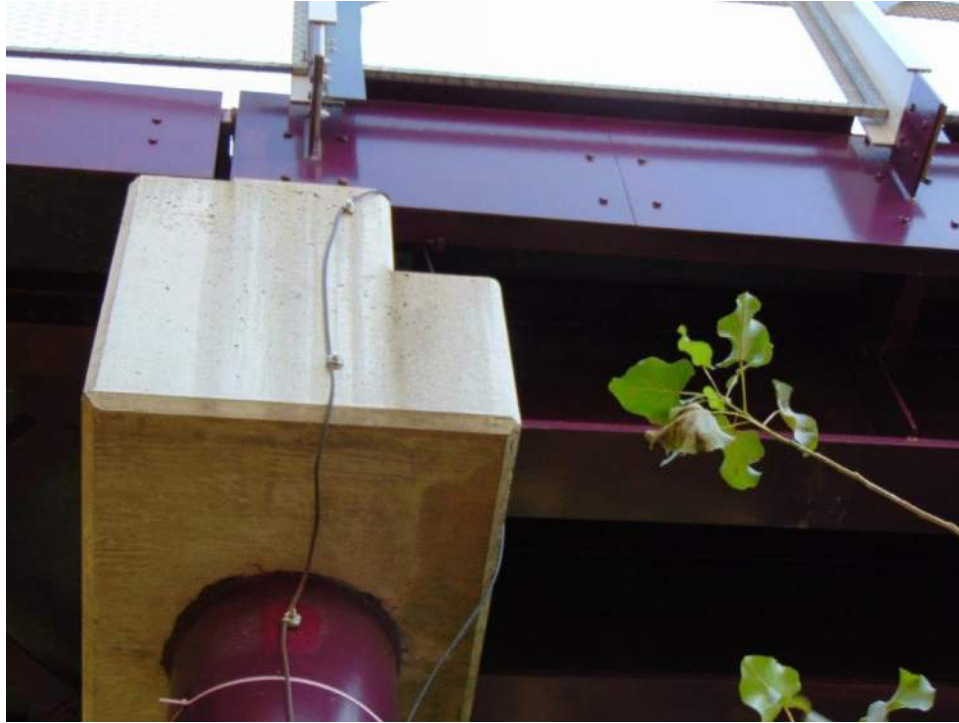
Photo 3. Grounding conductor 1/0 AWG. Pier 24 Northside

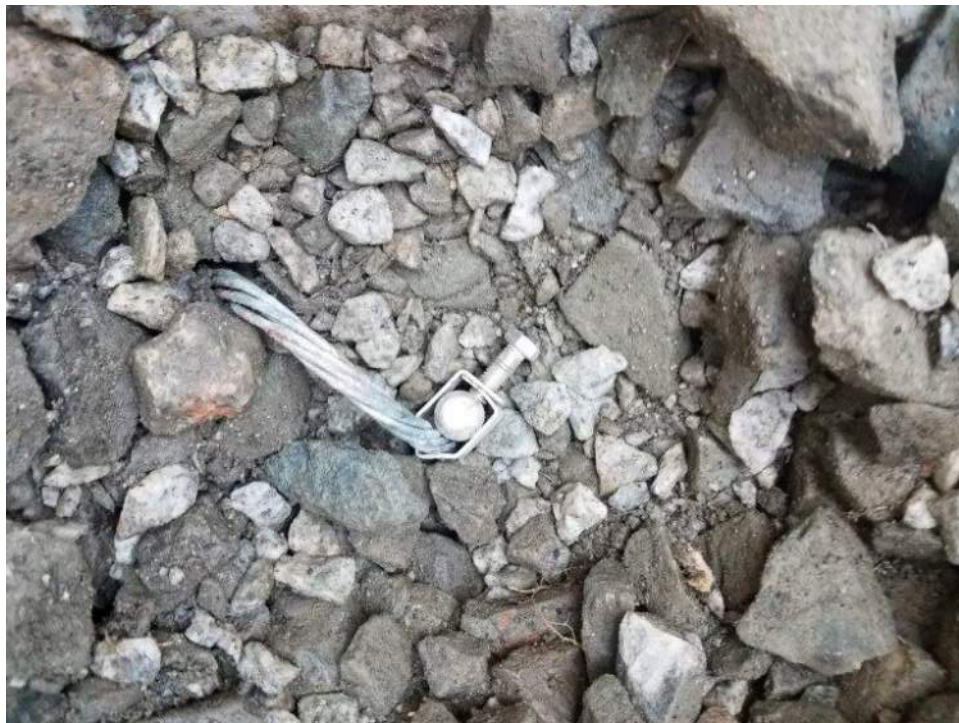
Photo 4. 3/4-inch SS grounding electrode.

2. Replace the stainless-steel ground rods with copper clad ground rods. (4 locations as shown on the drawings) or add supplemental (3-inch x 60-inch) graphite grounding electrodes backfilled with a low resistance coke breeze in parallel to improve conductivity. Stainless steel ground rods are approximately 74 microohms per centimeter, which is 40 times less conductive than copper.

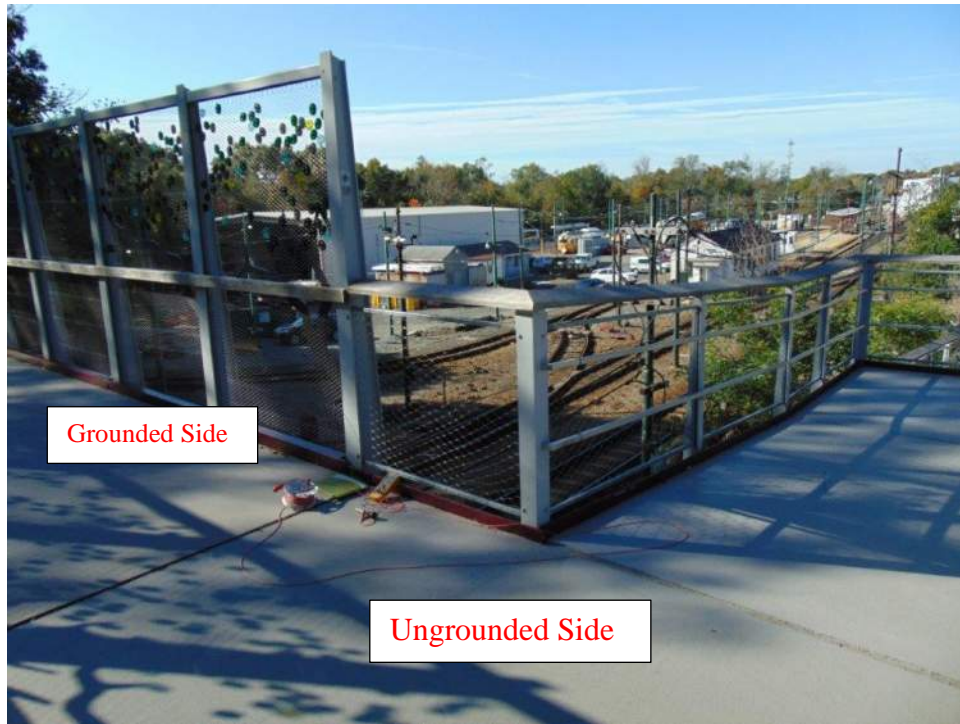
Continuity testing revealed that there is electrical isolation between the two bridge sections. It is recommended to electrically bond the north side of the bridge to the south side of the bridge where the grounding electrodes are attached to the bridge supports.

Photo 7. Bridge separation.
