MBTA Green Line Climate Change Vulnerability Assessment

Project Summary Presentation

June 14, 2022

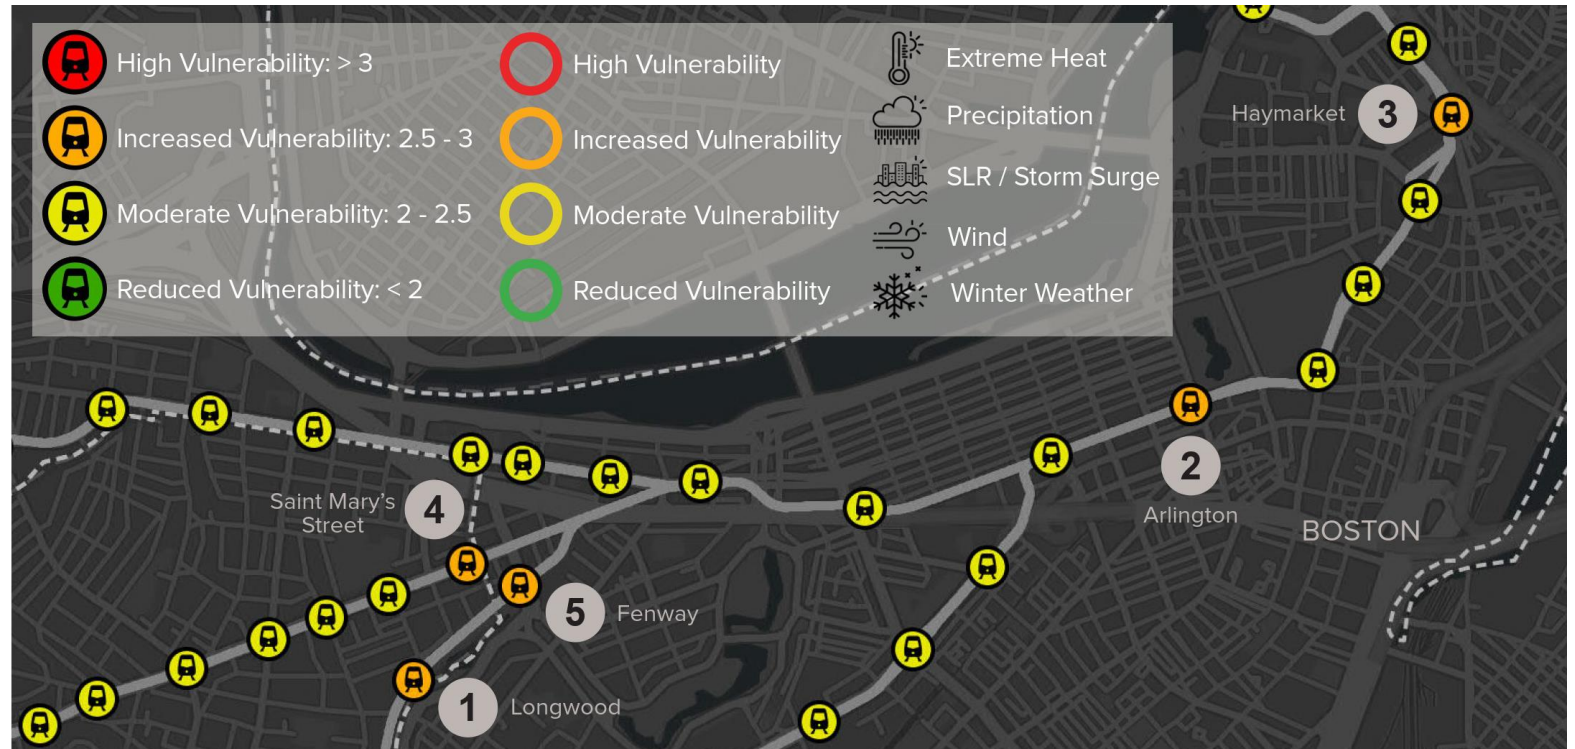
High sensitivity as station has many critical systems, has experienced extreme heat, precipitation and winter weather impacts, and is below ground

Low adaptive capacity as station is far from Riverside, has no backup generator and no flood protection system
