Z94PS08 - GEC Task Order No. 814

Shock Investigation of Fiber Reinforced Polymer
at the Mattapan DCR Pedestrian Bridge

January 2022

MBTA
Office of Chief Engineer
10 Park Plaza
Boston, MA 02116

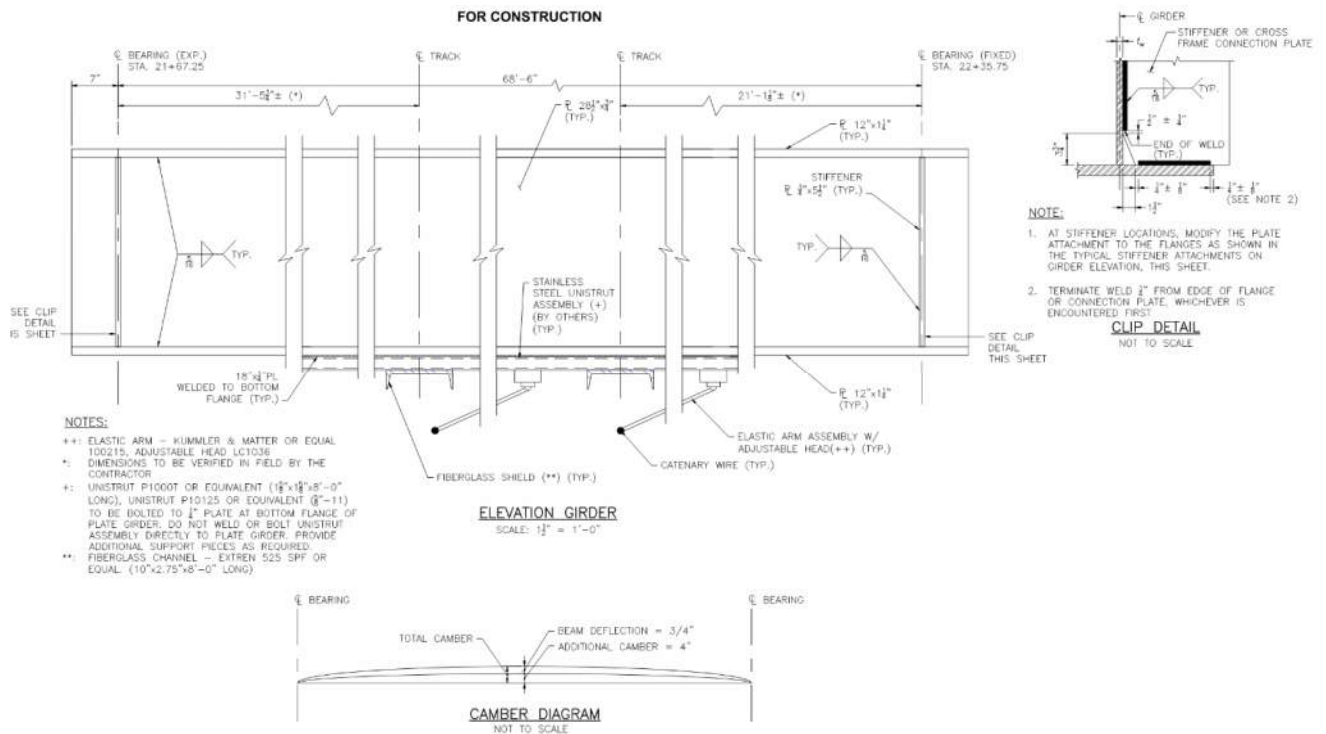
Underside of Bridge and the Catenary "shield"

The bottom of the bridge appears to conform with the design documents illustrating the fiberglass "shield" between the bridge structure and the overhead catenary wire.

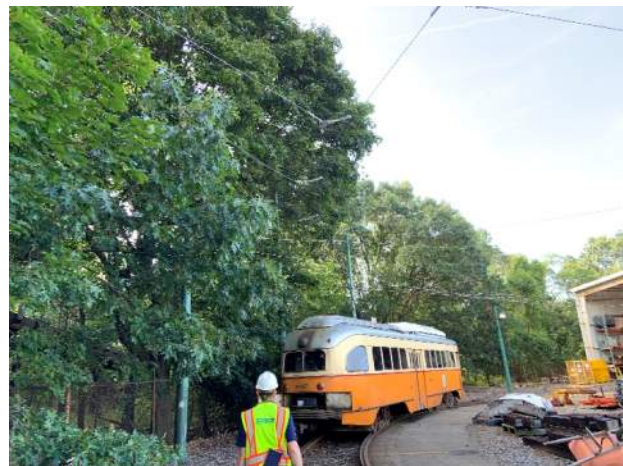
Maintenance Loop (Track Shown)

It was observed that the Mattapan station maintenance turn-around appears to have an overgrowth of tree limbs encroaching upon the overhead catenary lines and support cables. Some locations appear to be brushed by the trolley when passing. It is strongly recommended branches be trimmed back to the fence line to avoid any issues.

2. Cut back the tree overgrowth at the maintenance yard turnaround to keep branches off the overhead catenary and support systems. Branches should be cut back to the fence or beyond to avoid any possibility of contact with the catenary. Branches should also be trimmed back from making contact with the pedestrian bridge as well. There could be contact between the overhead catenary and the bridge via tree branches and if condition is very wet, a path could be established between the catenary and the bridge ramp.

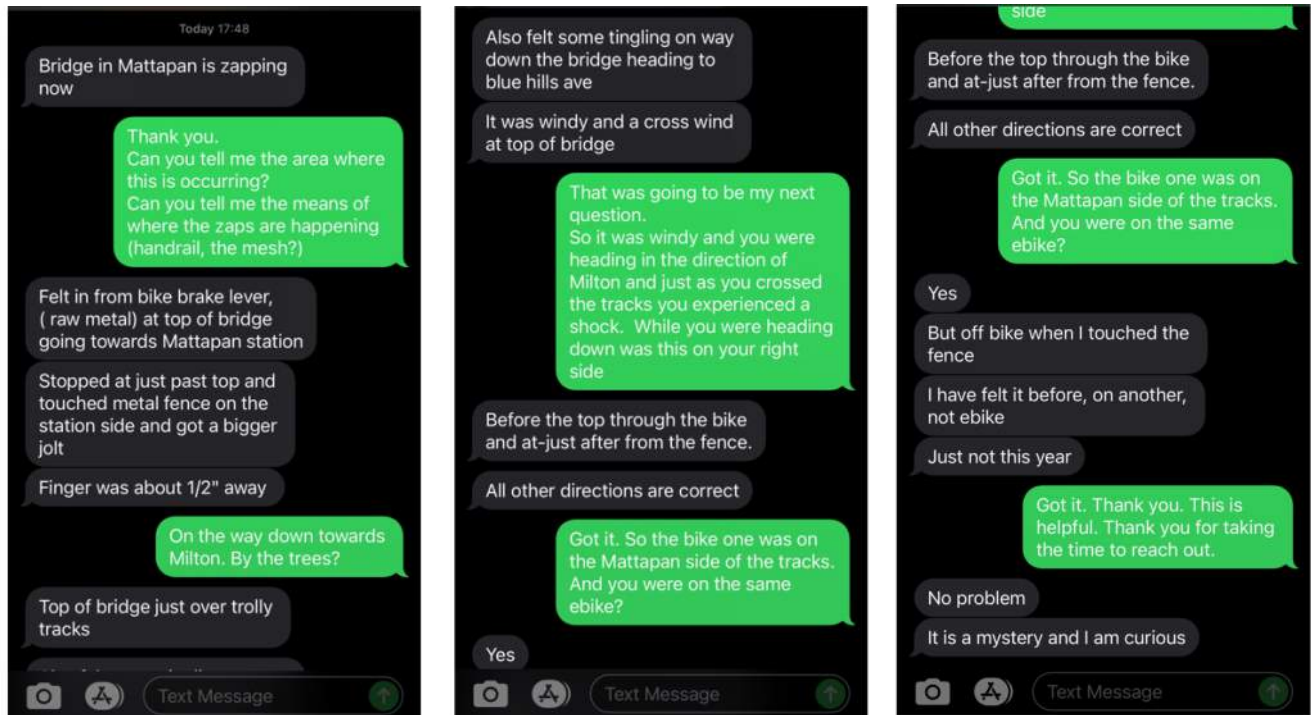
Screenshots of text messages

A person on an electric bicycle stopped when pedaling up the Milton side ramp and was shocked when touching the derailleur lever and the wire mesh at the same time. He indicated that this does not happen all the time but does happen when weather conditions are cold and dry. He also noted that it has also happened on his regular, non-electric bicycle.

The following is a text exchange between the bicyclist and Will Kunkle (MBI) regarding a shock incident the bicyclist experienced on the bridge.

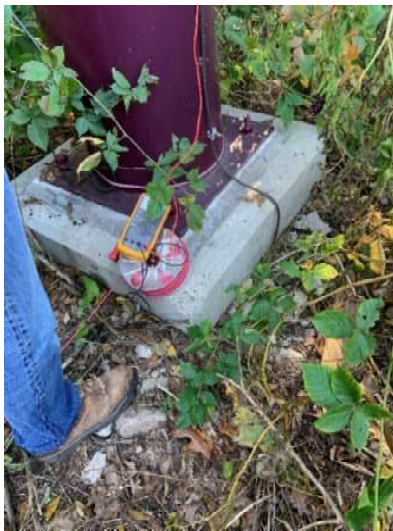
Bridge Pier 23

The installation was also accompanied by spot testing of the sub-structure and structures to check for continuity between the bridge and ramps. Discontinuity could potentially create a difference of potential between two (2) metallic and/or grounded surfaces.

CPI Field Measurements

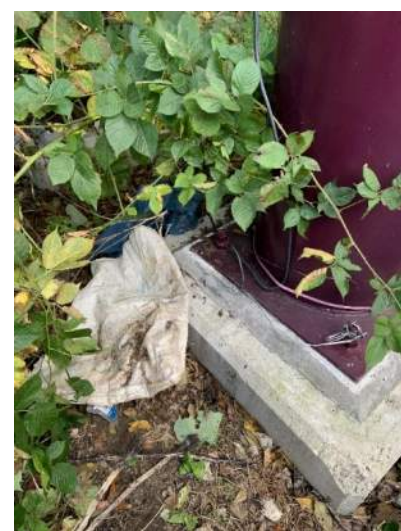
Bridge Pier 23

The installation of the data logger was conducted by CPI at the Pier 23 of the sub-structure on the Milton side of the track beyond the Right-of-Way fencing. The meter was installed to monitor any potential stray currents or voltages resulting from the negative return via the track of the traction power system.

Data Logger

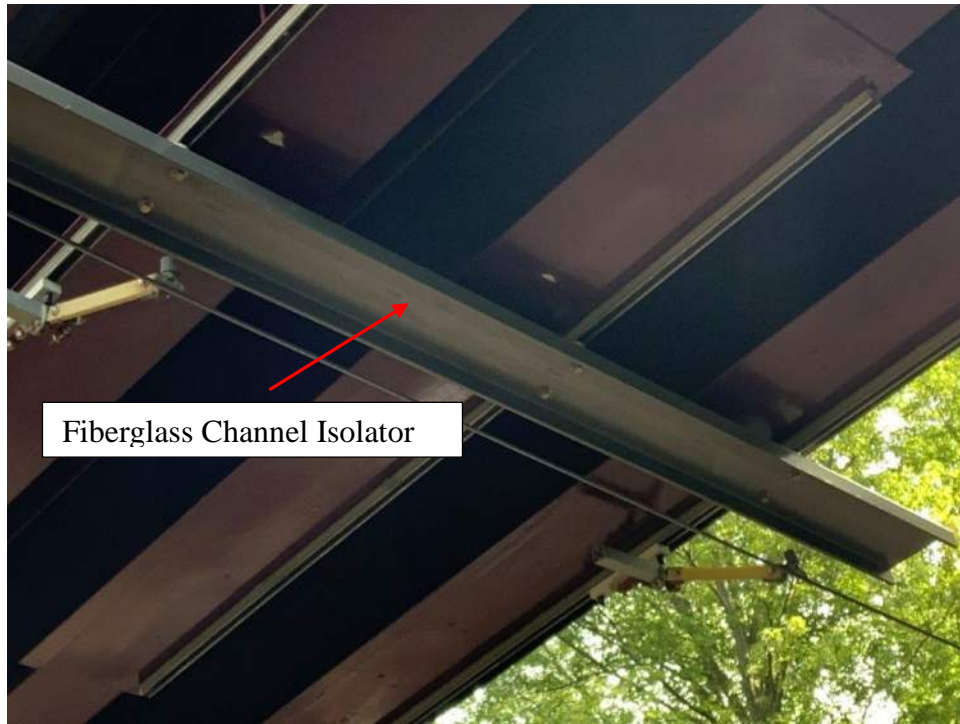
The MBTA trolley is supplied by 750 volts DC from an overhead catenary cable that is connected to the underside of the bridge. This catenary cable is electrically isolated from the bridge with spring-loaded guides and fiberglass insulating structures (**Photo 1**). The steel rails are assumed to be used as the return path for the negative side of the DC circuit.

Fiberglass Channel Isolator

Photo 1. Catenary cable under the FRP isolation.

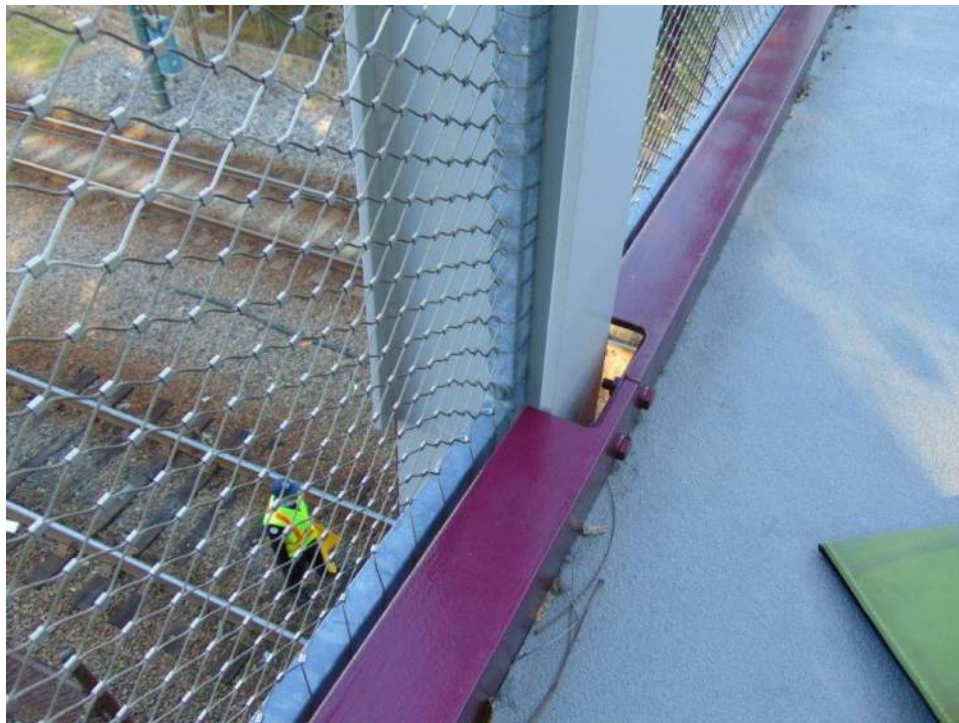
Photo 2. Different materials: AL, SS, CS, Gal CS, FRP.

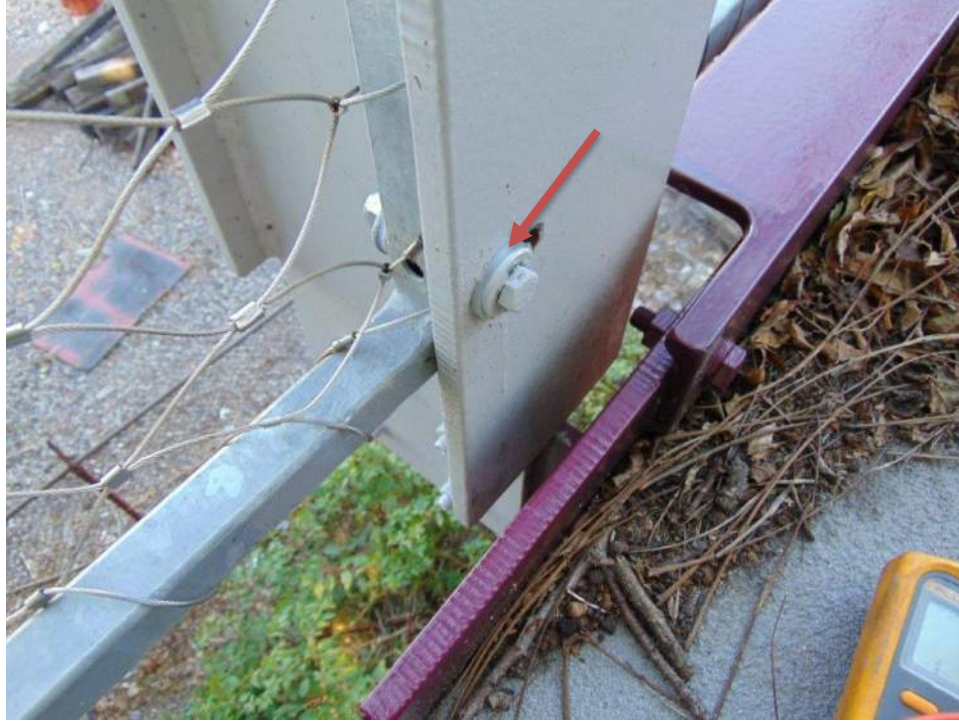
During the site visit on October 20, 2021, a stray current evaluation was conducted on the Mattapan Pedestrian bridge metallic components. The metallic structures on the bridge that were tested for electrical continuity included the CS pipe supports, AL fence post, and the SS fence screen. Isolating washers were observed between the 1-inch square Gal CS frames and the AL fence posts; however, these washers were not effectively isolating the two metals, due to alternate contact points (**Photo 5**). Observations made regarding the grounding electrodes are that four electrodes are installed at the bases of the four concrete pedestal pipe supports (**Photo 6**). The grounding conductor is attached to each pedestal pipe support and steel girder. The north section is not electrically connected to the grounding electrode or conductor.

Photo 5. Isolating washer.

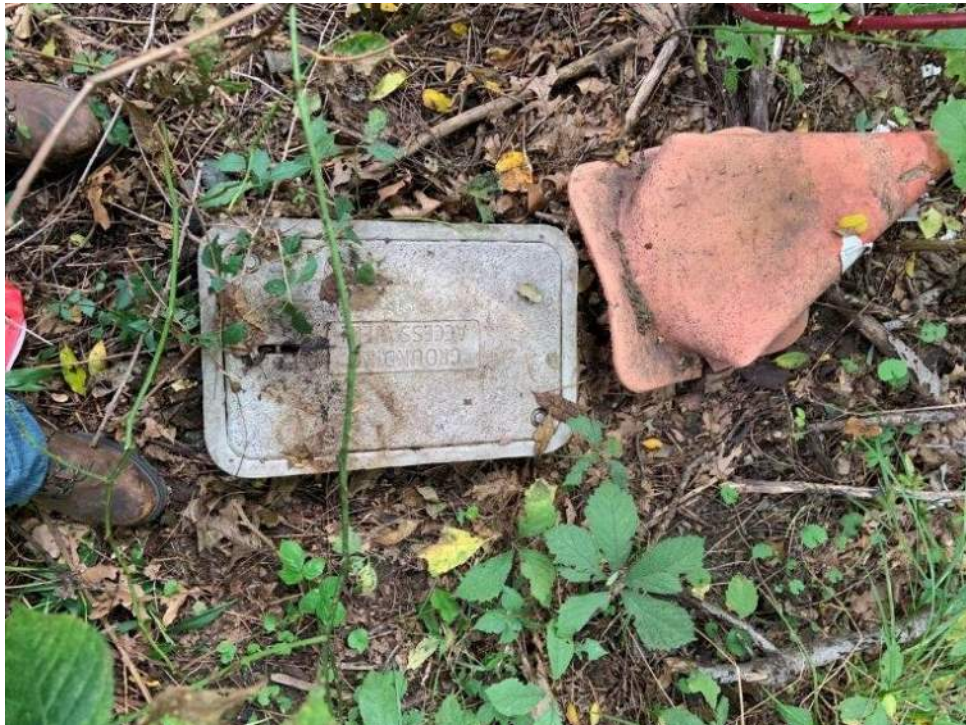
Photo 6. Grounding electrode location. Pier 23 Southside

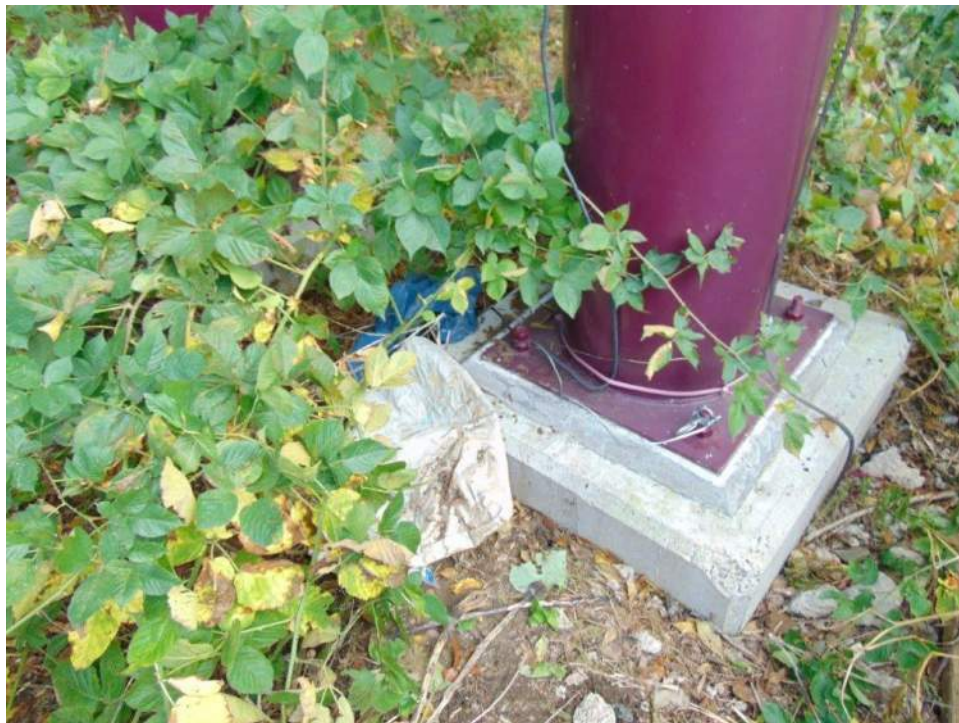
DL-1 data logger and CSE. The reference electrode was placed in the soil between the south girder support and the southbound (outbound) tracks (**Photo 8**). The data logger was removed from November 6th thru 8th to recharge the battery.

Photo 8. Data logger and reference electrode location. Pier 23

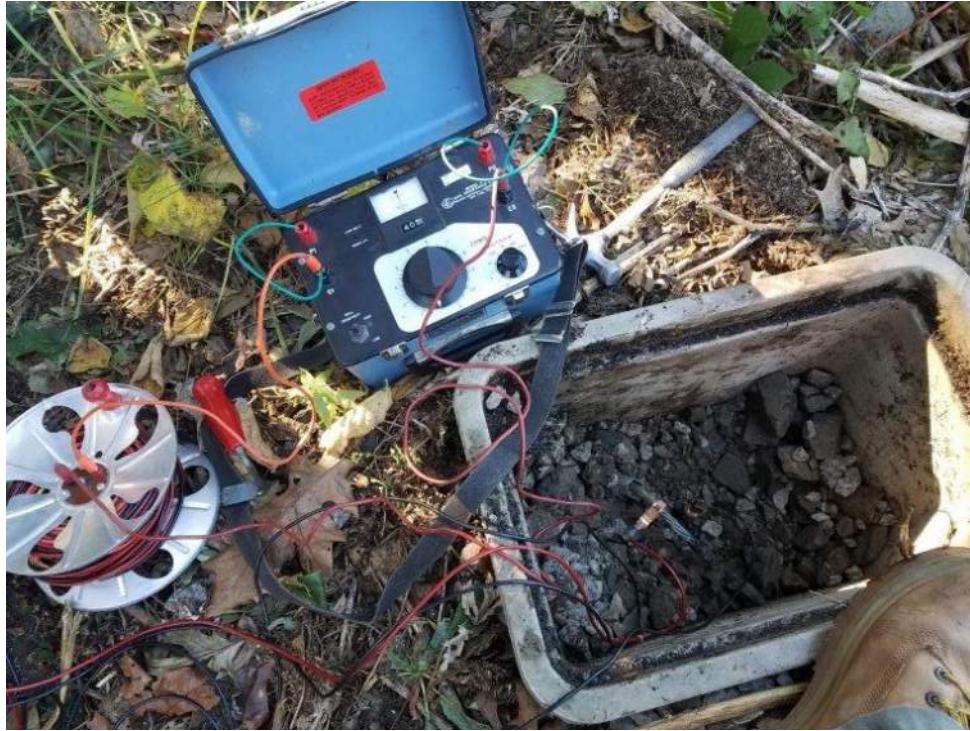
To determine the grounding electrode-to-earth resistance, three tests were conducted (**Photo 9**)—Wenner two-pin, three-pin and four-pin methods. The two-pin method was used to measure the actual resistance between two buried electrodes. The three-pin method was utilized to measure the actual electrode-to-earth resistance. The four-pin method was utilized to measure the soil resistivity; this resistivity is used in the theoretical calculation of the electrode-to-earth resistance utilizing Dwight's formula.

Photo 9. Grounding electrode resistance testing.
